Inspection Report
Minerals Regulatory Program

Mine Name: Deremo/Peterson

Permit number: M/037/025

Inspection Date: March 9, 2005

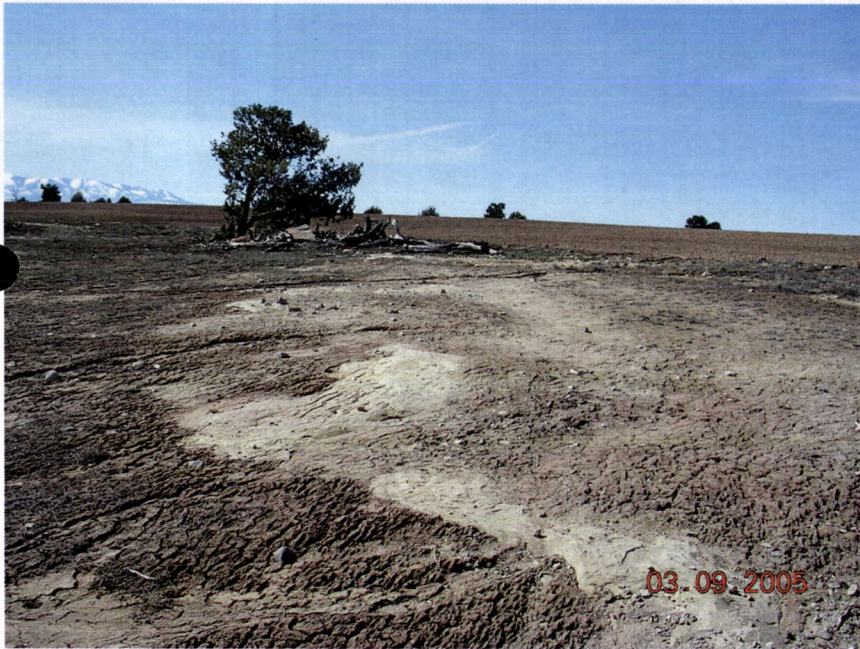
Photo 1. A view of the ore pad looking northeast toward an adjacent grain field. This photo show some rock outcrop that has become exposed (lower right extending up and left to near the center).

According to Mr. Barnett and Mr. Bates, the ore pad area was essentially a rock outcrop prior to mining, but soil was placed over the area and it was seeded when it was reclaimed. This area is shown in Photos 1 and 2. There is some vegetation, but it is sparse. There are also some places where the rock has become exposed.

While the ore pad may have been a rock outcrop with little vegetation, the plan does not contain a variance from revegetation requirements for this area. A variance may be justified, but until the operator applies for this variance and the Division approves it, the Division needs to require revegetation of this area.

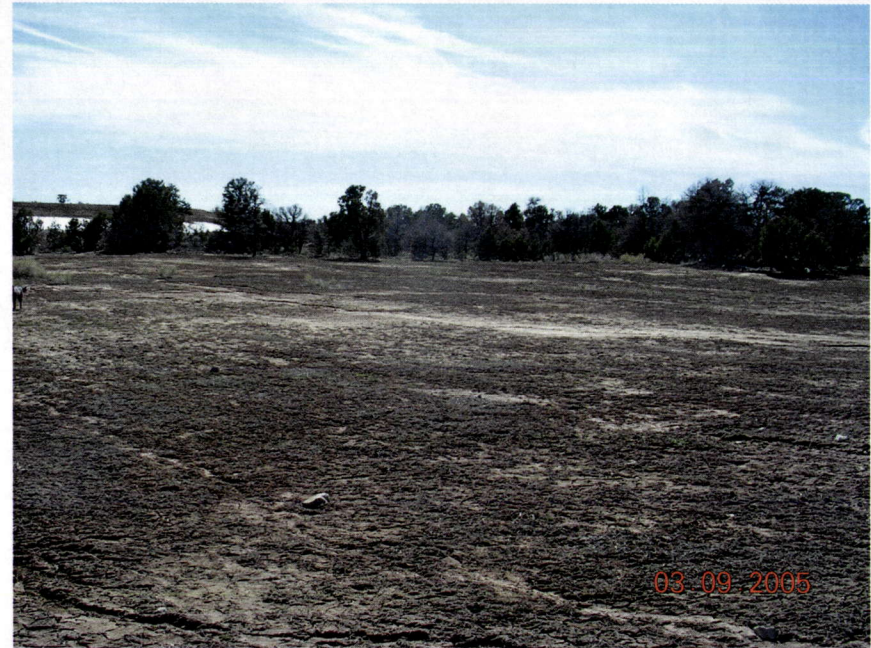
Photo 2. Another view of the ore pad looking toward the waste pile (the area in the background with snow).

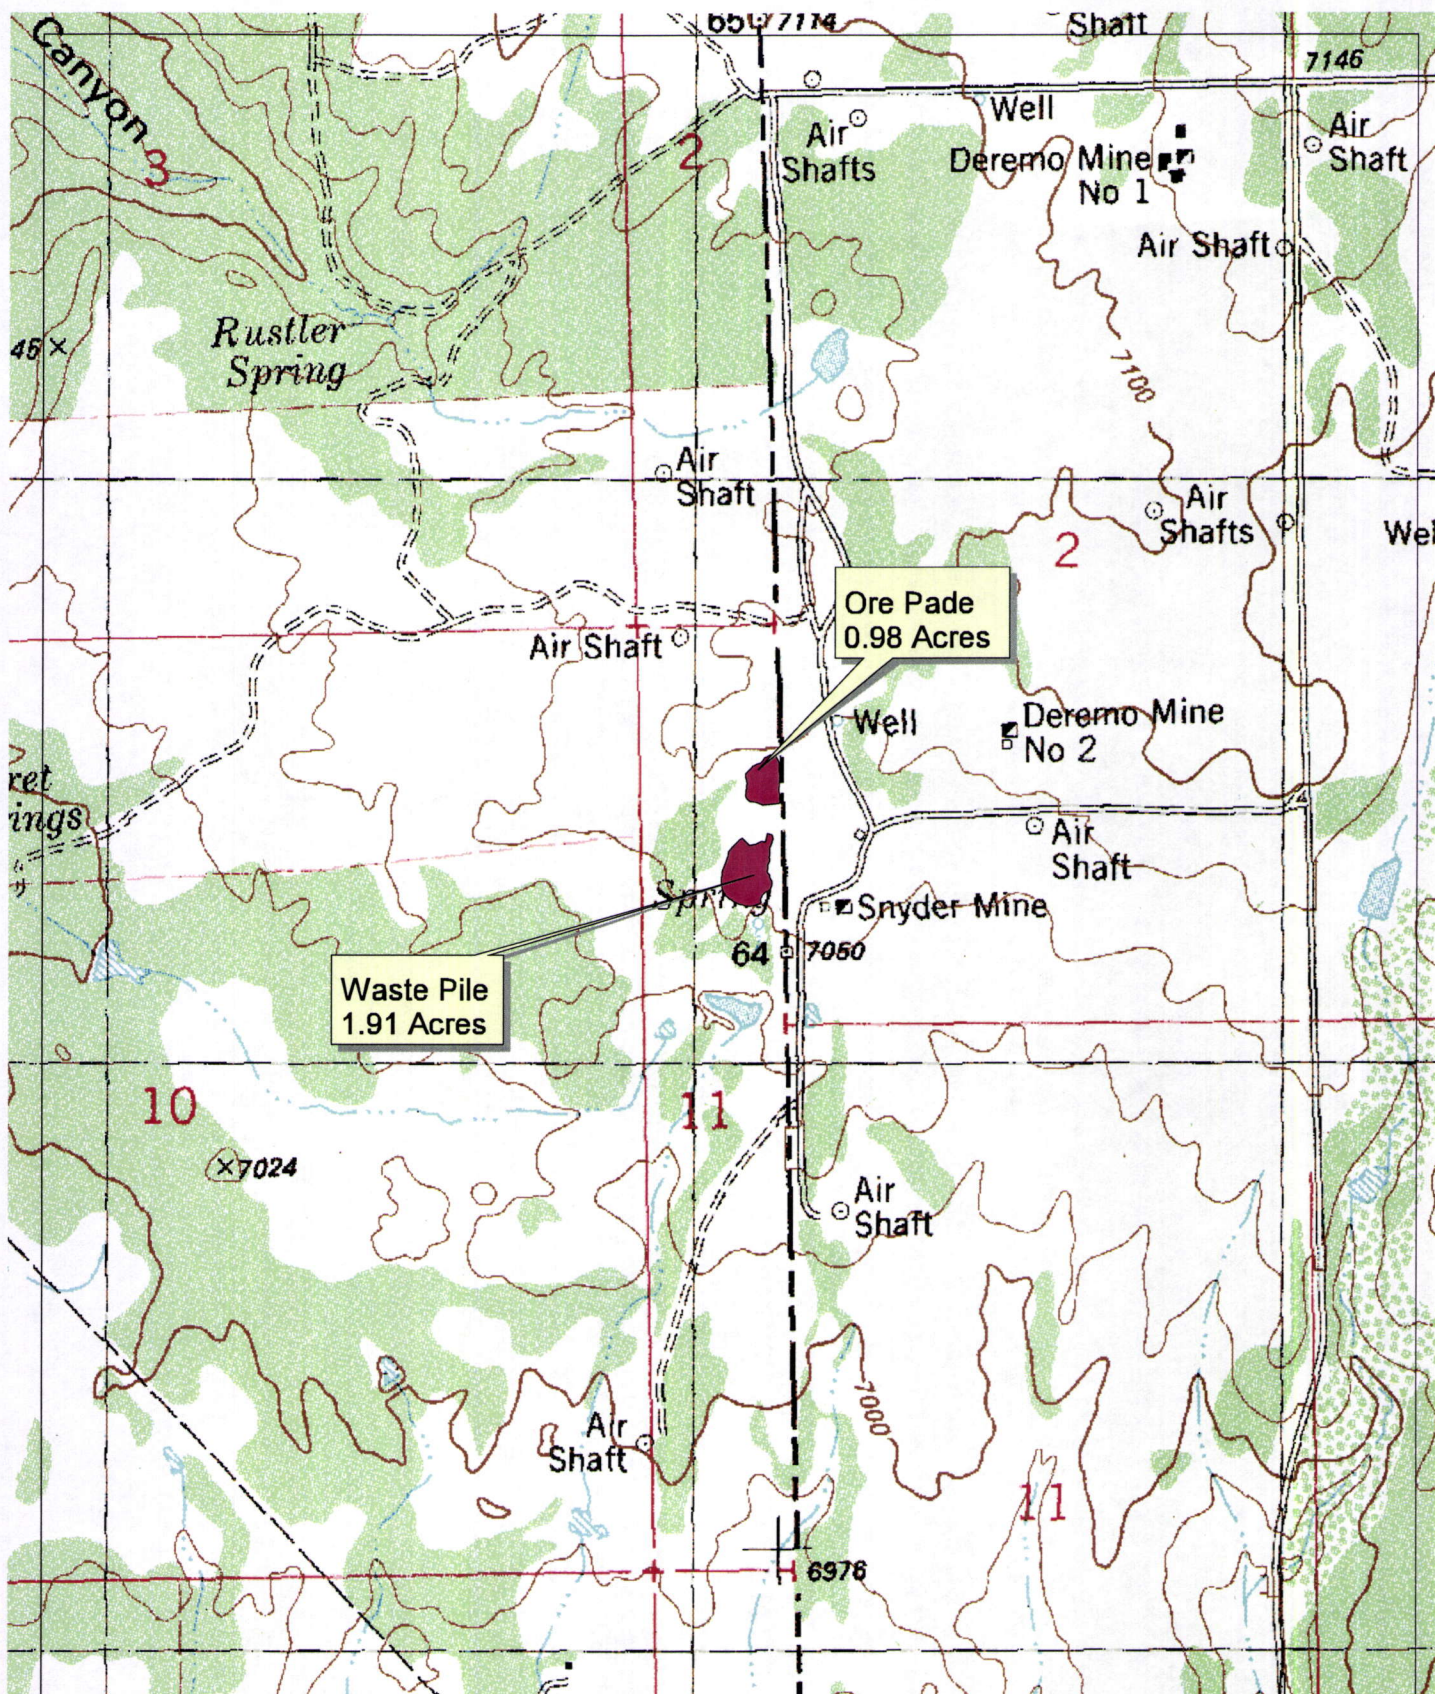
Mine Number: M/037/025
Mine Name: Deremo/Peterson
Township 33 S Range 26 E Section 11 SLBM
Piute Knoll Quad

I took GPS data around the ore pile and the portion of the waste rock pile where vegetation has not been adequately established. A copy of the map I created from this data is attached to this report. The total area where vegetation does not yet meet release criteria is 2.89 acres.
